PORT OF  
CAGAYAN DE ORO  
MISAMIS ORIENTAL

TITLE: <b>MAINTENANCE OF DAMAGED MANHOLE COVERS, PORT OF CAGAYAN DE ORO</b>		SHEET NO. <b>1</b>	
LOCATION: PORT OF CAGAYAN DE ORO		SHEET CONTENTS	
PREPARED BY: <i>Karel T. Sumicad</i> KAREL T. SUMICAD Construction Foreman	SUBMITTED BY: <i>Marc M. Avellana</i> MARC M. AVELLANA Supervising Engineer A	RECOMMENDED BY: <i>Antonio M. Torcino, Jr.</i> ANTONIO M. TORCINO, JR. Acting ESD Manager	APPROVED: <i>Fernando B. Mapalo, Jr.</i> FERNANDO B. MAPALO, JR. Acting Port Manager
		LOCATION PLAN	
		<b>2</b>

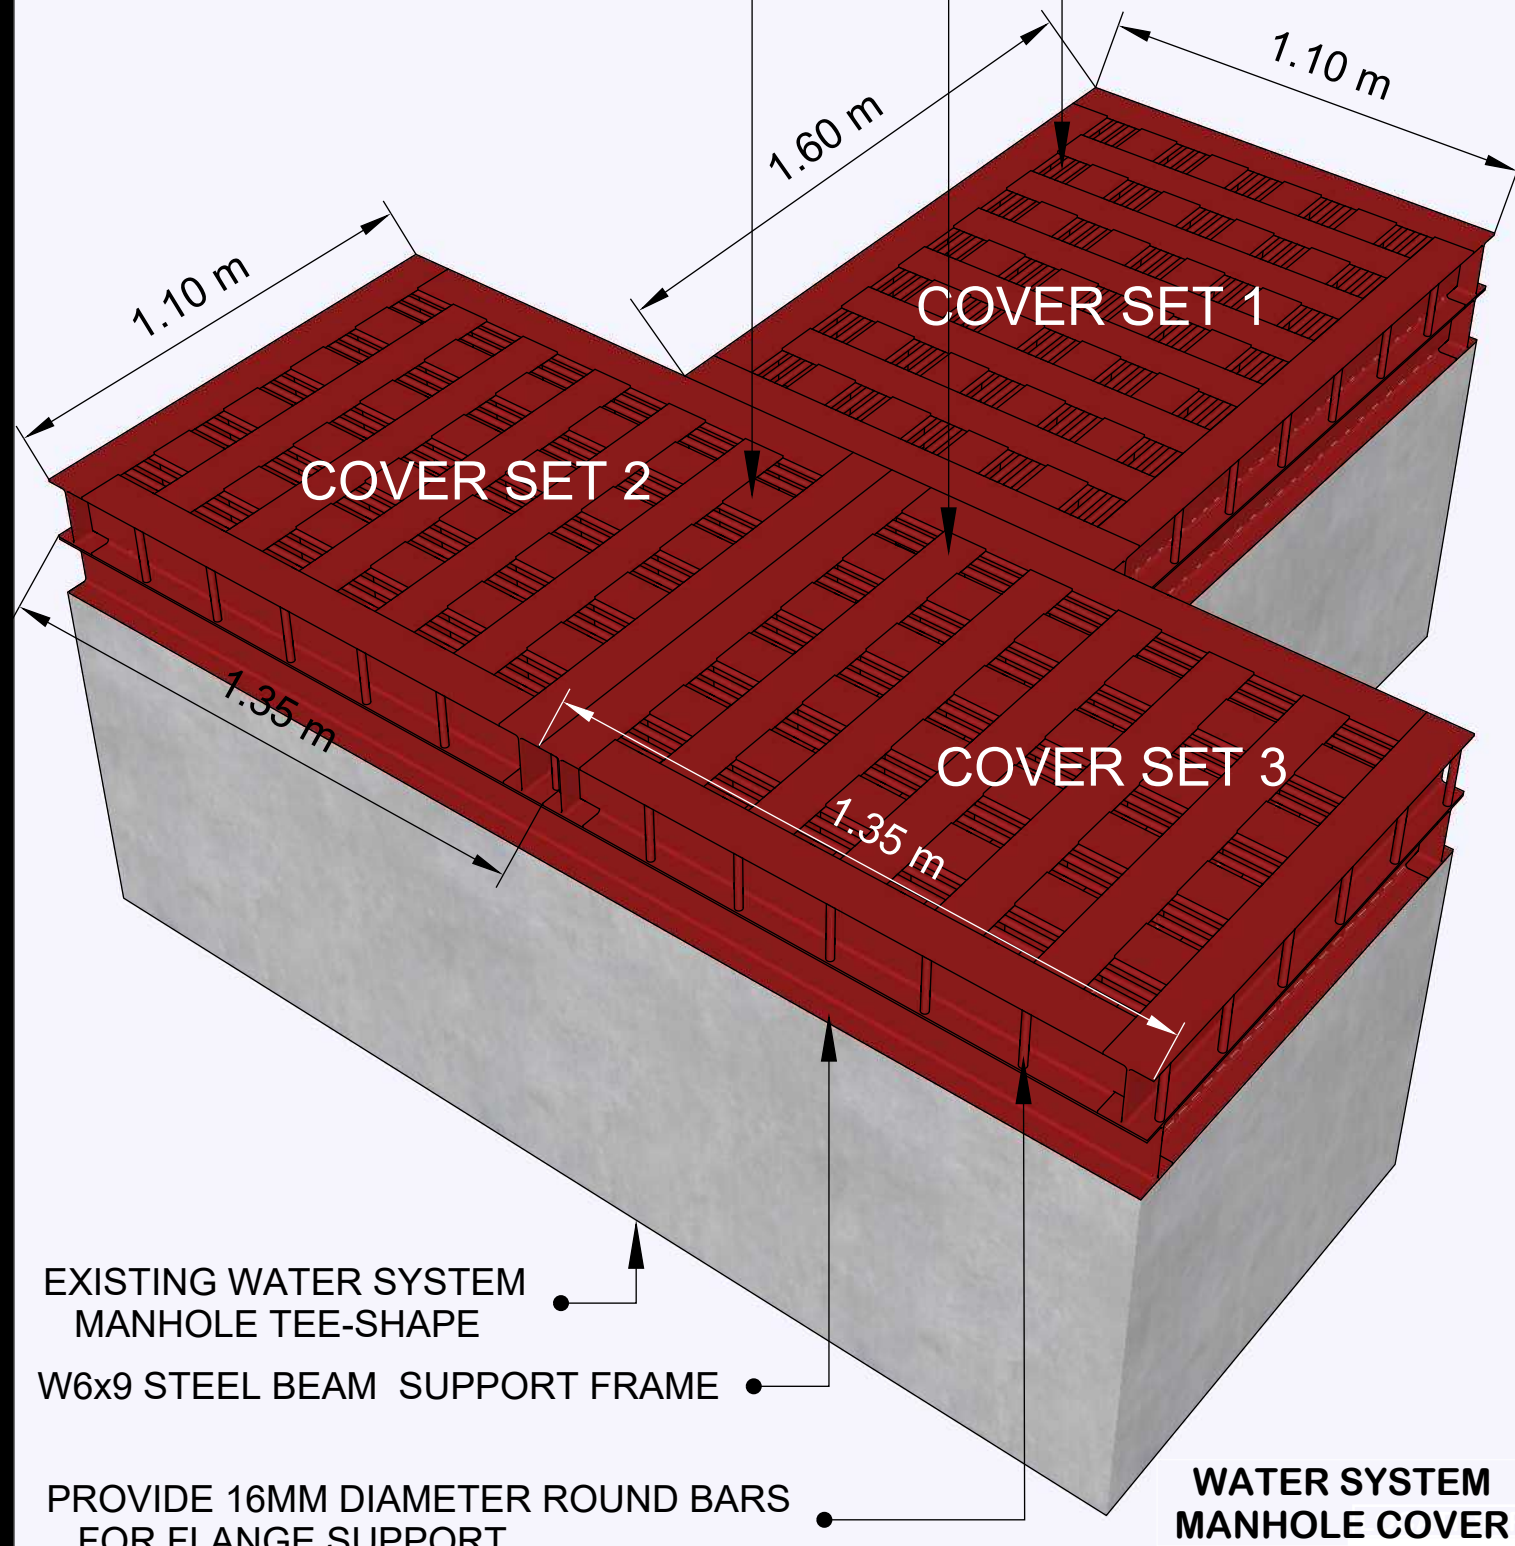
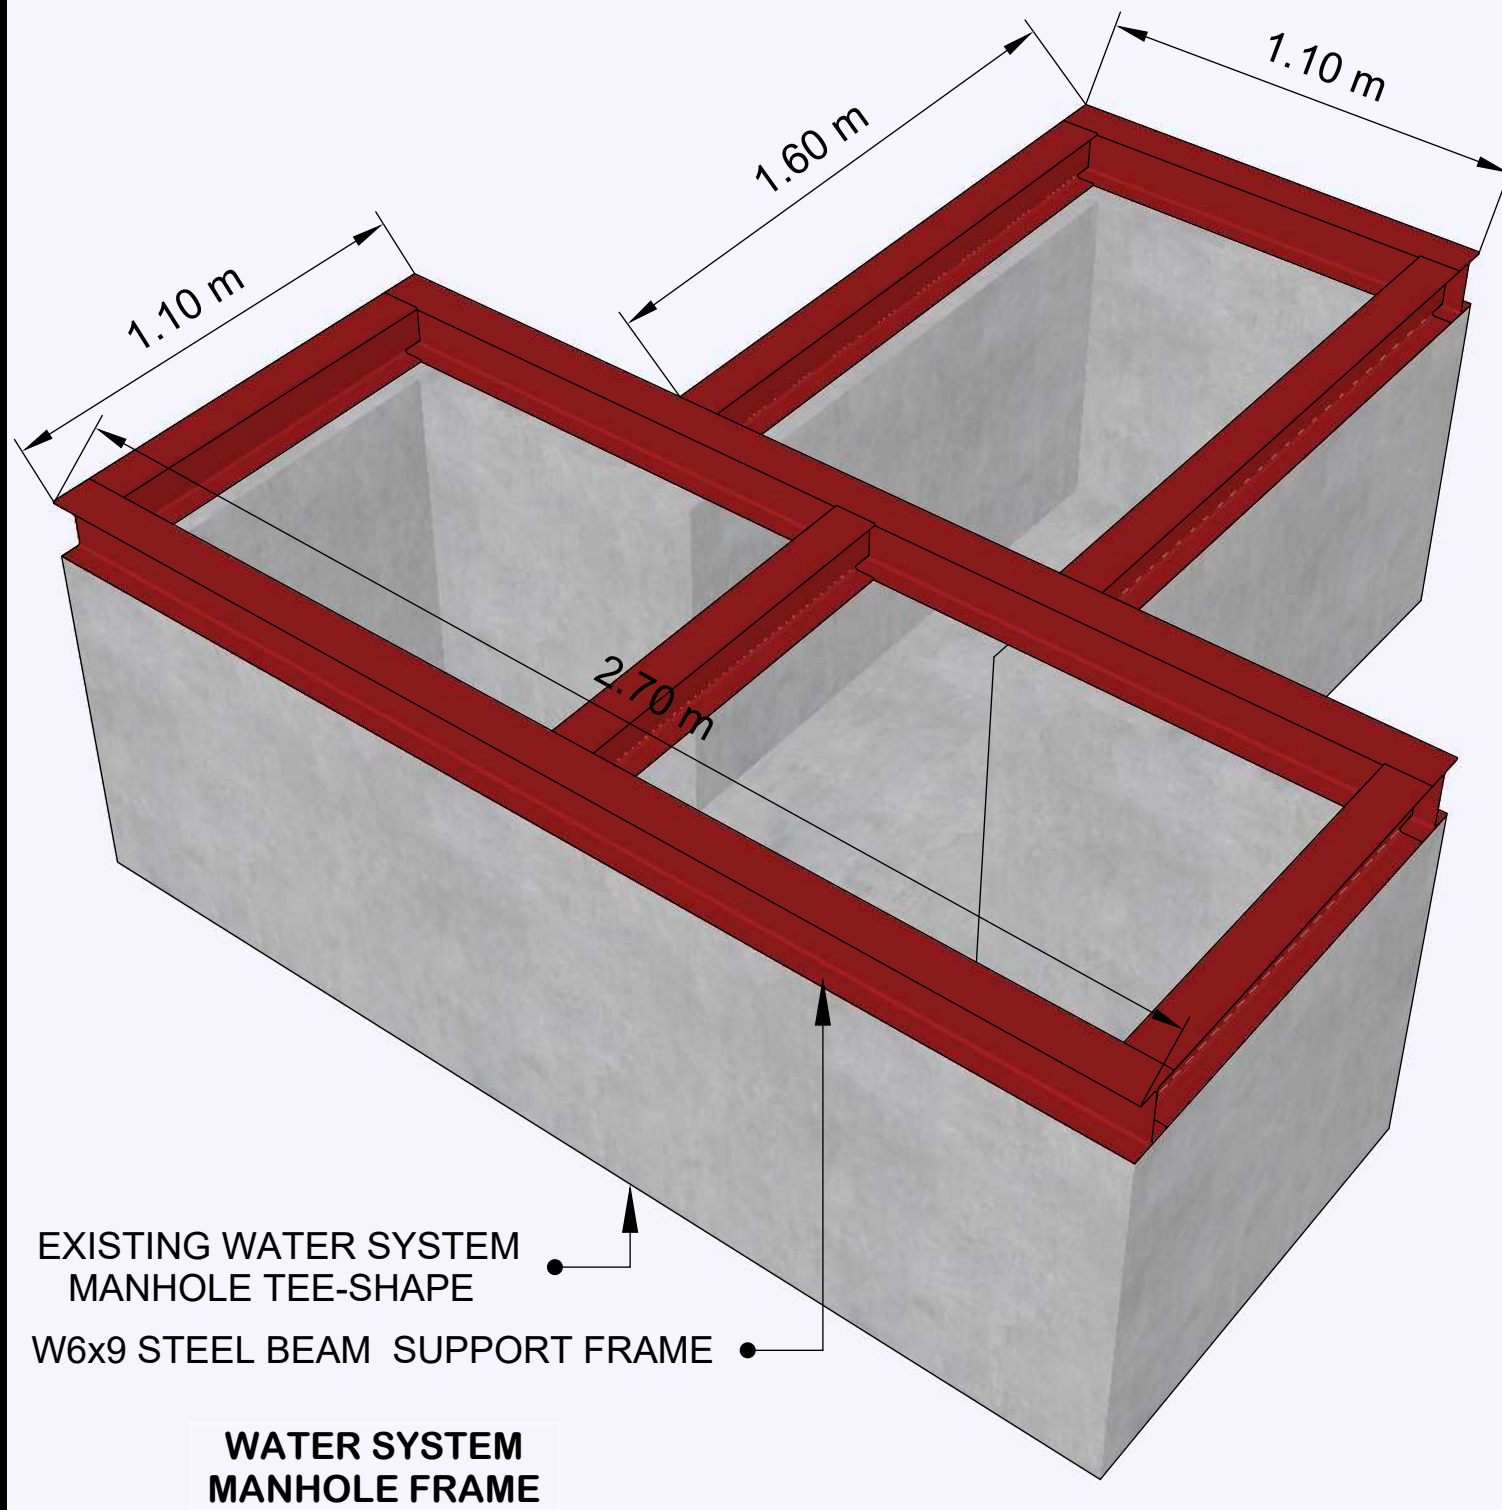
PROVIDE 4PCS. 16MM DIAMETER  
SUPPORT ROUND BARS SPACED  
AS SHOWN

W6x9 STEEL BEAM MAIN

W6x9 STEEL BEAM BRIDGING
